2021

LAKE THUNDERBIRD WATERSHED ALLIANCE

INTEGRATED WATERSHED MANAGEMENT PLAN

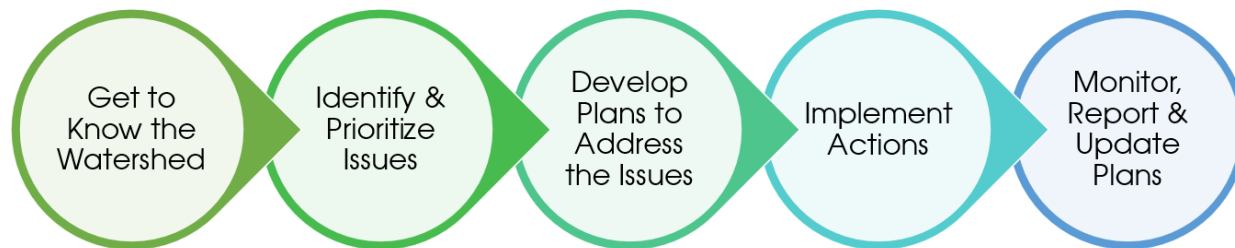
Figure 1.

IWMP Process

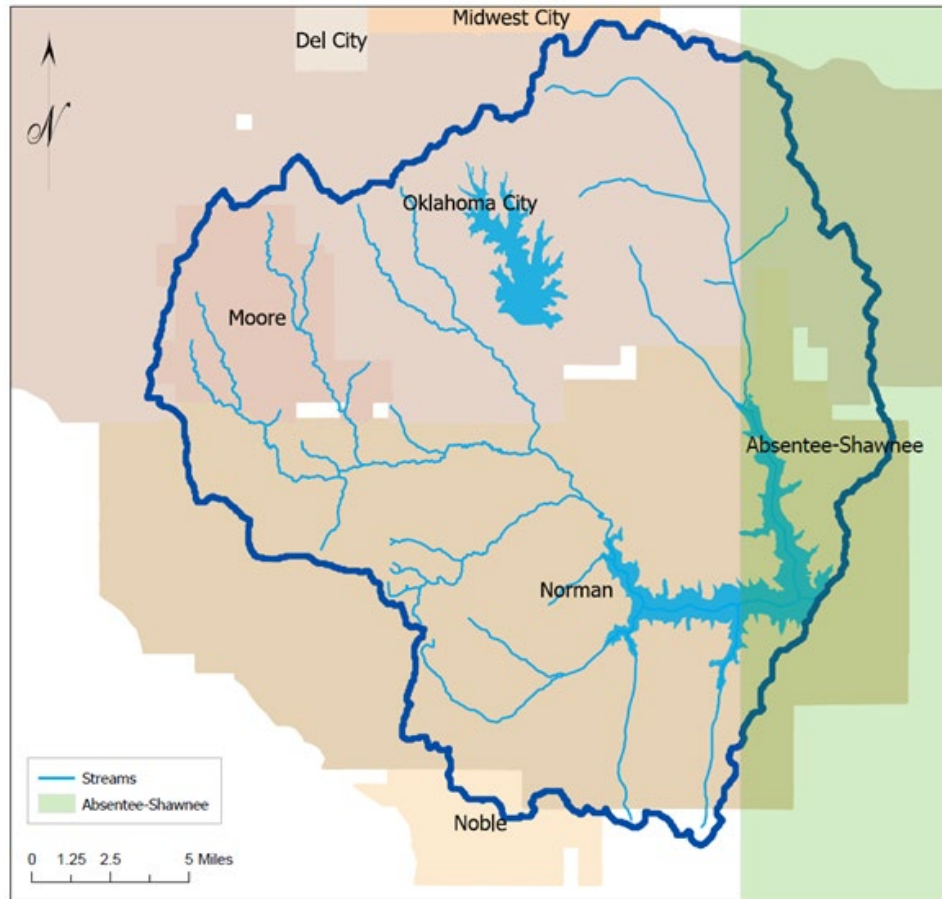
Figure 2

Moore. Midwest City and Noble have small sections within the central and southern portion of the boundary, respectively. In addition, the Absentee-Shawnee Tribe's boundary extends into the eastern part of the watershed (see Figure 2).

Lake Thunderbird Watershed Boundaries

The Lake Thunderbird watershed has an area of 256 square miles of residential, commercial, and agricultural lands. It encompasses the southeast section of Oklahoma City, the majority of Norman, and most of Moore. Midwest City and Noble have small sections within the central and southern portion of the boundary, respectively. In addition, the Absentee-Shawnee Tribal boundary extends into the eastern part of the watershed (see Figure 1).
